## Rehabilitating Historic Storefronts

H. Ward Jandl

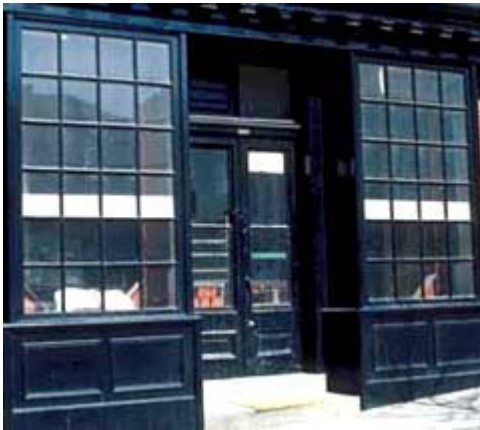
This cast iron storefront from the late 19th century has been well maintained over the years. Photo: NPS files.

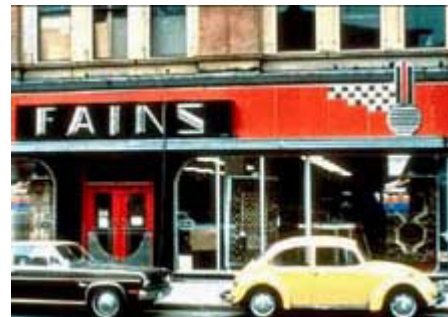
This 1930s Moderne storefront has gained significance over time and should be preserved. Photo: NPS files.

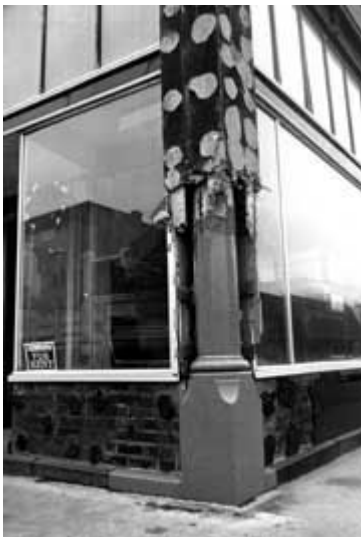
Storefronts of the 1940s, 50s, and 60s

were frequently installed by attaching studs or a metal grid over an early front and applying new covering materials. Photo: Bob Dunn.

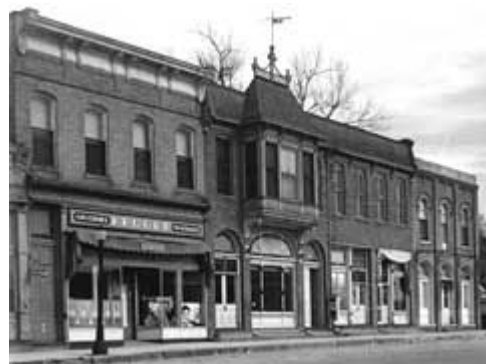
By evaluating the components of a storefront as well as their existing condition, a successful rehabilitation is more likely. Photo: HABS collection, NPS.

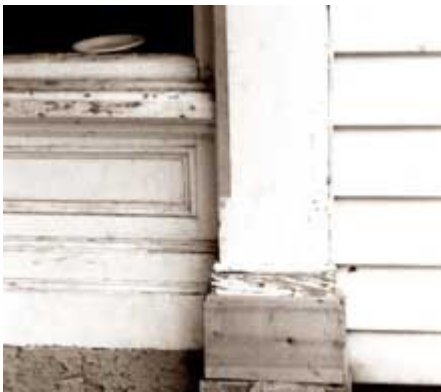
Rather than replace an entire wooden storefront, a new wooden component can be pieced-in, as seen in this column base. Photo: NPS files.

Where components of wood storefronts are so badly deteriorated that they cannot be stabilized, it is possible to replace the deteriorated parts with new pieces. These techniques all require skill and some expense, but are recommended in cases where decorative elements, such as brackets or pilasters, are involved. In some cases, missing edges can be filled and rebuilt using wood putty or epoxy compounds. When the epoxy

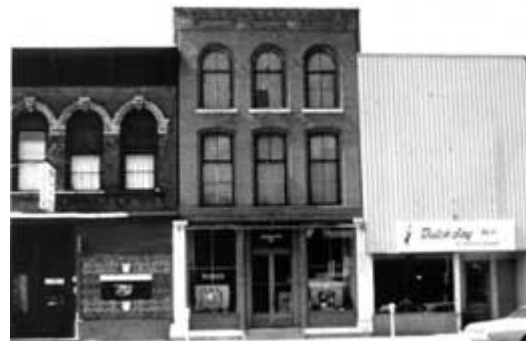
This photograph shows the impact of preserving historic storefronts. The one on the right has been totally obscured by a "modern" front added in the 1950s. Photo: NPS files.

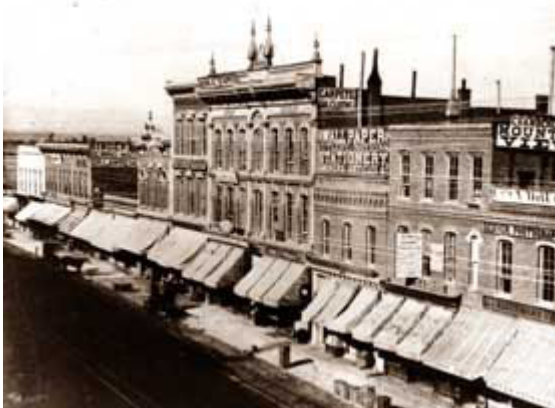
Try to locate old photographs or prints to determine what alterations have been made to the storefront and when they were undertaken. Awnings were common elements of storefronts at the turn of the century. Photo: NPS files.
